Assistance with Safety Evaluation for Two Dams

Richard Gillespie

- Geotechnical investigation, analysis and recommendations for the construction of the downstream dam to comply with the NJDEP requirements for Class III dams
- Design drawings and specifications for the refurbishment of a breached and partially constructed dam

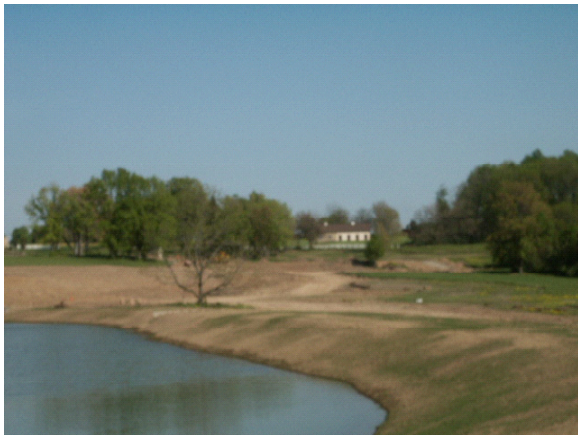
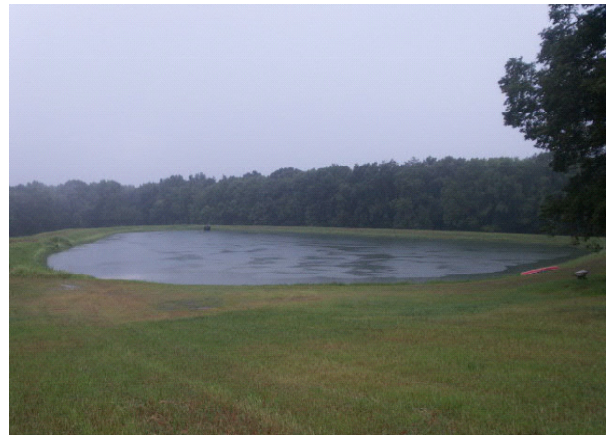
To insure the continued stability of the two dams, global slope stability and veneer stability of the GCL and the cover soil were performed. The slope stability analysis was performed using the computer program X-STABL. The program performs a two-dimensional limit equilibrium analysis to compute the Factor of Safety for a layered slope according to the general limit equilibrium method, Janbu's Generalized Procedure of Slices, Simplified Bishop, and Simplified Janbu. In addition, the veneer stability of each component of the linear system was evaluated, including the stability of the GCL itself, the GCL/subgrade soil interface and the GCL/cover soil interface. The stability of the GCL liner itself was calculated using the hydrated strength

of the bentonite clay sandwiched between the two geotextiles. The stability of the GCL/subgrade interface and the GCL/cover soil interface were calculated utilizing the interfacial friction angle between the different surfaces.

SAI examined several aspects of the earth dam to ensure the performance and stability of the structure. A seepage analysis was performed to determine the amount of water flowing through the dam. A flow net diagram was constructed for the existing dam. It was concluded that there was an excessive amount of seepage, and that remedial measures should be taken to reduce it. Accordingly, SAI recommended that the inside slopes of the dam be lined with a material of low permeability; specifically, a geosynthetic clay liner (GCL). In addition, the Factor of Safety against rapid draw down was calculated utilizing the Stability Charts developed by Spenser.
